FIELD FLOOR IMPACT INSULATION

TEST REPORT

U1501 MELBOURNE RESIDENCES, 111 MELBOURNE ST, SOUTH BRISBANE

TITLE Field Floor Impact Insulation Tests
U1501 Melbourne Residences, 111 Melbourne St, South Brisbane,
QLD 4101.
Test Report

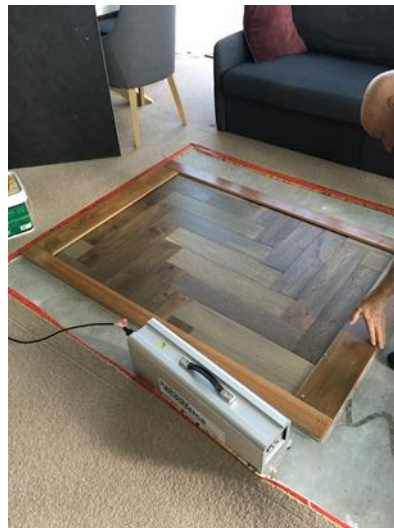
Figure 1: Testing in the living room of Unit 1501

Transmitting Room (Living Room of Unit 1501 on Level 15)

Receiving Room (Living Room of Unit 1401 on Level 14)

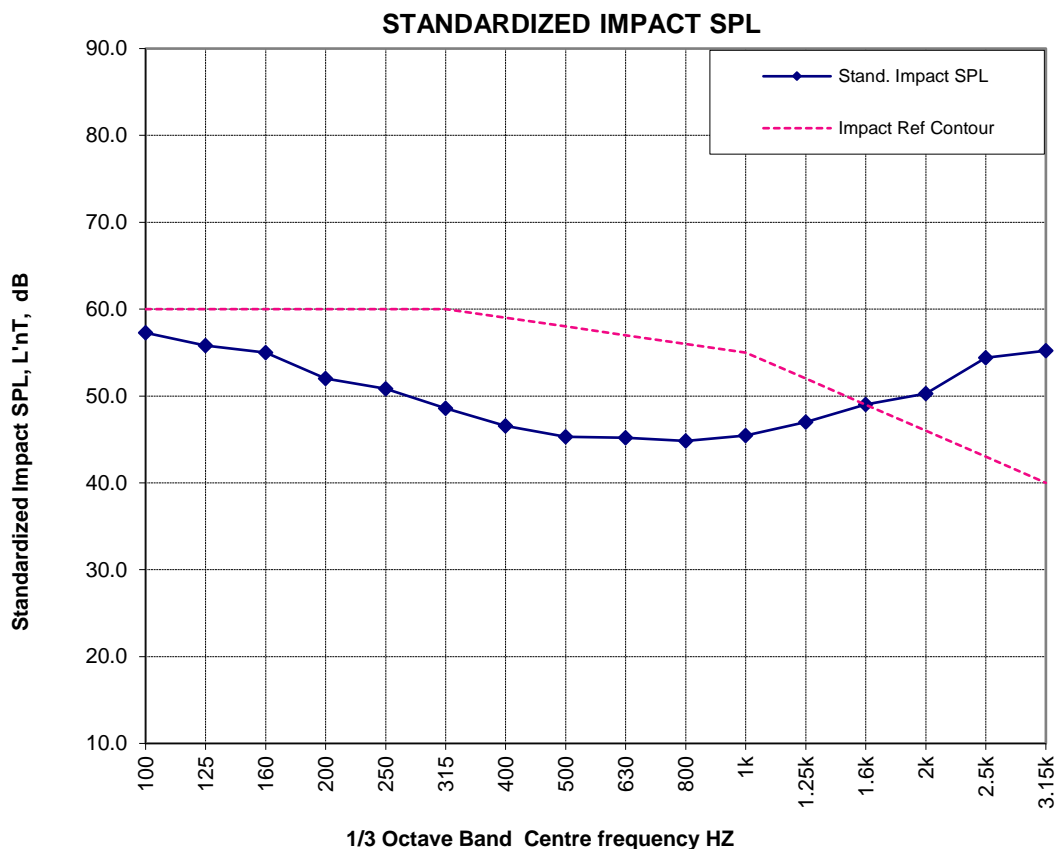
Test 1 of 3

Bare concrete slab

DESCRIPTION OF FLOOR AND SPECIMEN
 Test Surface: Bare concrete slab
 Underlay:
 Adhesive:
 Ceiling: Plasterboard
 Slab: Concrete
No. of Source posn: 2
Mic. posn: 2 sweeps
RT meas: 5 Imp.
SLM: Nor 140

Weighted Standardized Impact SPL **L'nT,w** **58**
 Results standardized to a RT of 0.5 seconds **CI (L'nT,w)** **-9** ISO 16283-2:2015 & 717-2:2013

Centre Frequency Hz	Stand. Impact SPL dB	Impact Ref Contour dB	Deficiencies dB
100	57.3	60	
125	55.8	60	
160	55.0	60	
200	52.0	60	
250	50.8	60	
315	48.6	60	
400	46.5	59	
500	45.3	58	
630	45.2	57	
800	44.8	56	
1k	45.4	55	
1.25k	47.0	52	
1.6k	49.0	49	0.0
2k	50.3	46	4.3
2.5k	54.4	43	11.4
3.15k	55.2	40	15.2
Total

L'nT,w 58 30.9

Test System	L'nT,w	CI	L'nT,w + CI
1.	Bare concrete slab	58	-9	49
2.	15-4mm Herringbone Timber flooring sample (Glued)	45	1	46
3.	15-4mm Herringbone Timber flooring sample (Glued) + 5mm Dunlop Duralay Technics underlay (Glued)	45	1	46

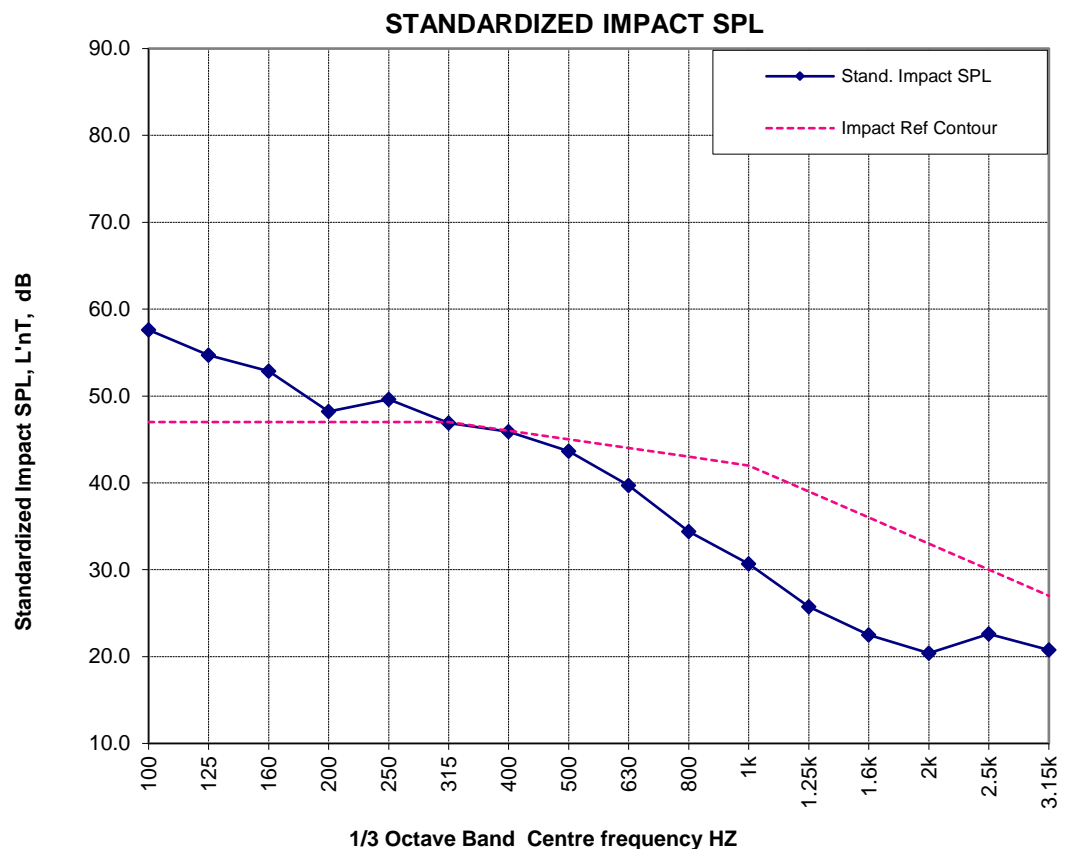
Test 2 of 3

15-4mm Herringbone Timber flooring sample (Glued)

DESCRIPTION OF FLOOR AND SPECIMEN
 Test Surface: 15-4mm Herringbone Timber flooring sample (Glued)
 Underlay:
 Adhesive: Glued
 Ceiling: Plasterboard
 Slab: Concrete
No. of Source posn: 2
Mic. posn: 2 sweeps
RT meas: 5 Imp.
SLM: Nor 140

Weighted Standardized Impact SPL **L'nT,w** **45**
 Results standardized to a RT of 0.5 seconds **CI (L'nT,w)** **1** ISO 16283-2:2015 & 717-2:2013

Centre Frequency Hz	Stand. Impact SPL dB	Impact Ref Contour dB	Deficiencies dB
100	57.6	47	10.6
125	54.7	47	7.7
160	52.9	47	5.9
200	48.2	47	1.2
250	49.6	47	2.6
315	46.9	47	
400	45.9	46	
500	43.7	45	
630	39.7	44	
800	34.4	43	
1k	< 30.7	42	
1.25k	< 25.7	39	
1.6k	< 22.5	36	
2k	< 20.4	33	
2.5k	22.6	30	
3.15k	20.8	27	
Total

L'nT,w 45 28.0

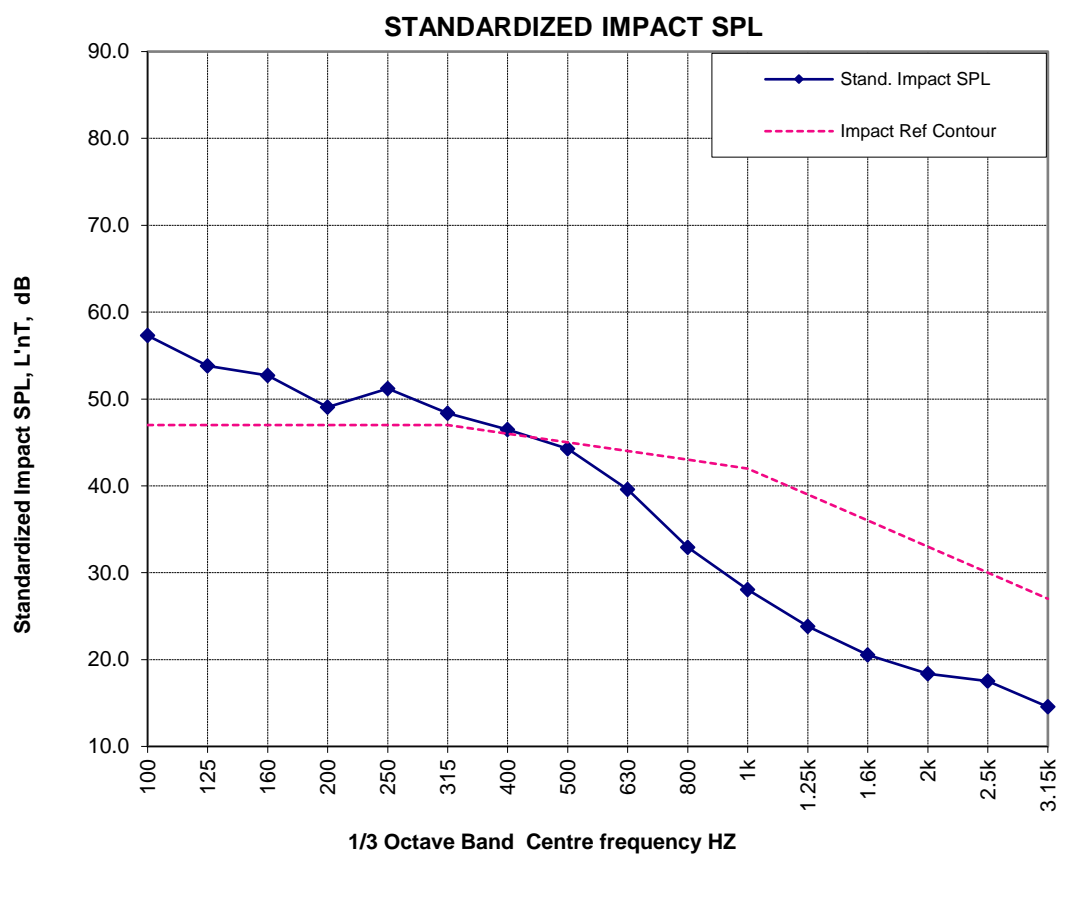
Test 3 of 3

15-4mm Herringbone Timber flooring sample (Glued)

5mm Dunlop Duralay Technics underlay (Glued)

DESCRIPTION OF FLOOR AND SPECIMEN
 Test Surface: 15-4mm Herringbone Timber flooring sample (Glued)
 Underlay: 5mm Dunlop Duralay Technics underlay (Glued)
 Adhesive: Glued
 Ceiling: Plasterboard
 Slab: Concrete
No. of Source posn: 2
Mic. posn: 2 sweeps
RT meas: 5 Imp.
SLM: Nor 140

Weighted Standardized Impact SPL **L'nT,w** **45**
 Results standardized to a RT of 0.5 seconds **CI (L'nT,w)** **1** ISO 16283-2:2015 & 717-2:2013

Centre Frequency Hz	Stand. Impact SPL dB	Impact Ref Contour dB	Deficiencies dB
100	57.3	47	10.3
125	53.8	47	6.8
160	52.7	47	5.7
200	49.1	47	2.1
250	51.2	47	4.2
315	48.3	47	1.3
400	46.5	46	0.5
500	44.3	45	
630	39.6	44	
800	32.9	43	
1k	< 28.0	42	
1.25k	< 23.8	39	
1.6k	< 20.5	36	
2k	< 18.4	33	
2.5k	< 17.5	30	
3.15k	< 14.6	27	
Total

L'nT,w 45 31.0

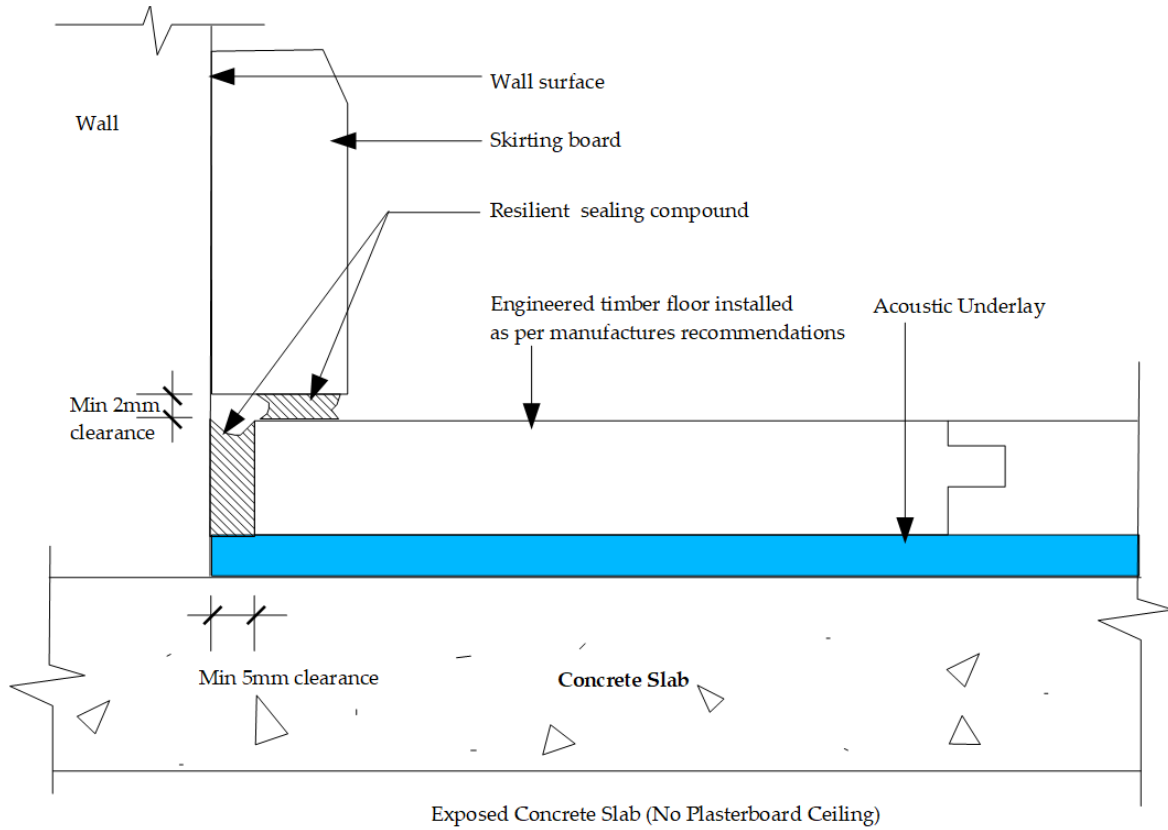
APPENDIX D

Installation - Engineered timber floor with acoustic underlay

- i). In our experience, test samples are similar in performance to an entirely laid floor ($\pm 2\text{dB}$).
- ii). The impact layer must be applied strictly following the manufacturer's recommended procedures to achieve the maximum rating. We recommend a minimum of 5mm clearance around the floor's perimeter to avoid pressure on walls and adjacent surfaces. Fill the gap with a resilient sealant. Refer to Appendix D for detail.
